NRL/MR/6180--99-8423

Thermal Insult Produced by the Residual Liquid Fuel in a Missile Hit Scenario

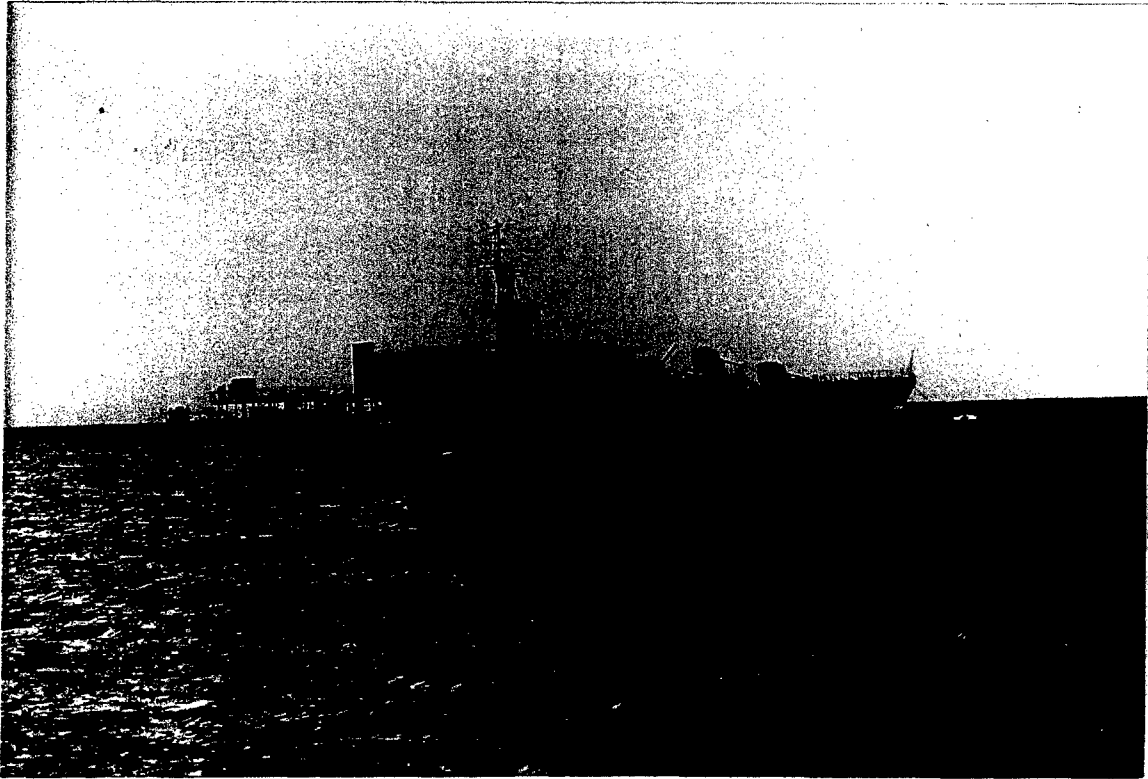
Fig. 1 - ex-Margottini

Two tests were conducted on board the decommissioned BERGAMINI Class frigate, the ex-MARGOTTINI (Fig. 1). The ship is approximately 95 m (311 ft) long, 11.3 m (37 ft) wide and displaces 1500 metric tons (1650 English tons). The test compartment was located on the Corridoio Deck between frames 36 and 48 as shown in Fig. 2. The size and shape of the compartment had to be modified due to damage sustained during a previous blast test. The final compartment dimensions are shown in Fig. 3.

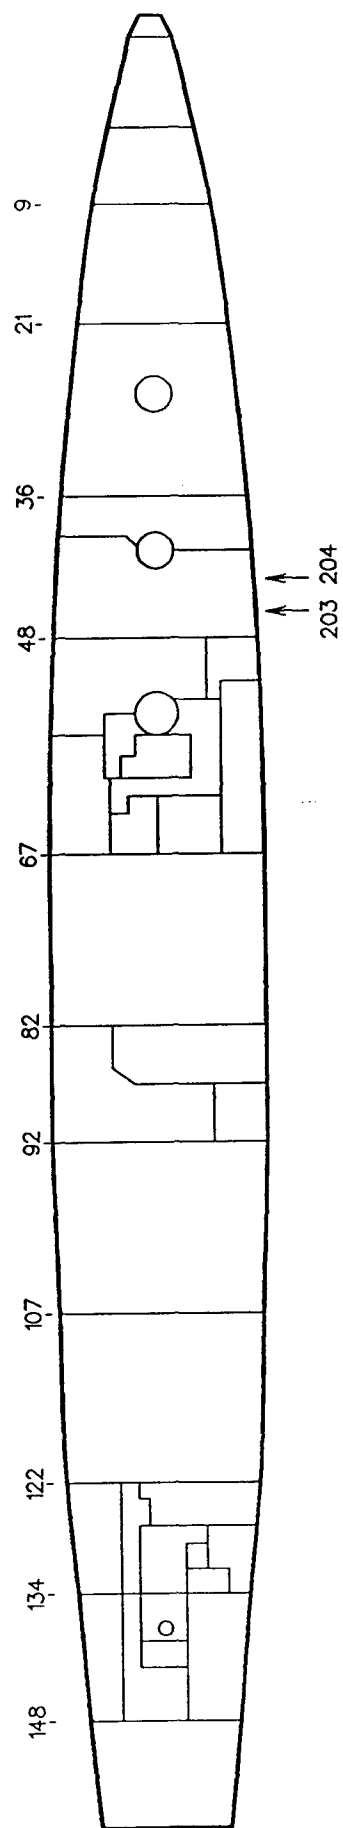
Fig. 2 - Test compartment location - Corridoi deck

The charges were mounted on platforms on the exterior of the starboard hull at locations shown in Figs. 2 and 3. The warheads were fired horizontally through the compartment at a height of approximately 1.3 m (50 in.) above the deck. A 5 cm (2 in.) thick steel plate was fastened to the port side of the ship to contain the blast. The warhead was initially aligned using a laser.

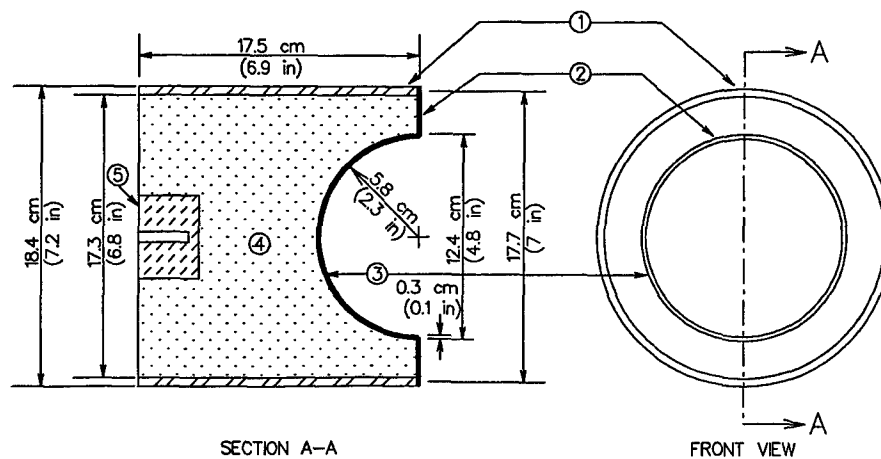
Fig. 4 - Shaped charge

The shaped charge consisted of a 6.3 kg (14.0 lb) of C-4 plastic explosive with a 100 g (0.2 lb) 50/50 Pentolite booster. The explosive was housed in a 18.4 cm (7.25 in.) diameter cylinder (OD) by 17.5 cm (6.9 in.) in length as shown in Fig. 4. The casing was 1.0 cm (0.4 in.) thick and was made of 1008 steel. The charge was activated using a J-2 or RP-80 detonator.

MATERIALS LIST		
PART	DESCRIPTION	MATERIAL
1	CASING	18.4 cm (7.2 in) OD x 17.1 cm (6.7 in) ID TUBING
2	DISC	16 ga. MLD STEEL
3	LINER	AISI 1008 STEEL
4	EXPLOSIVE FILL	14 lb HBX-1
5	BOOSTER	100 g 50/50 PENTOLITE

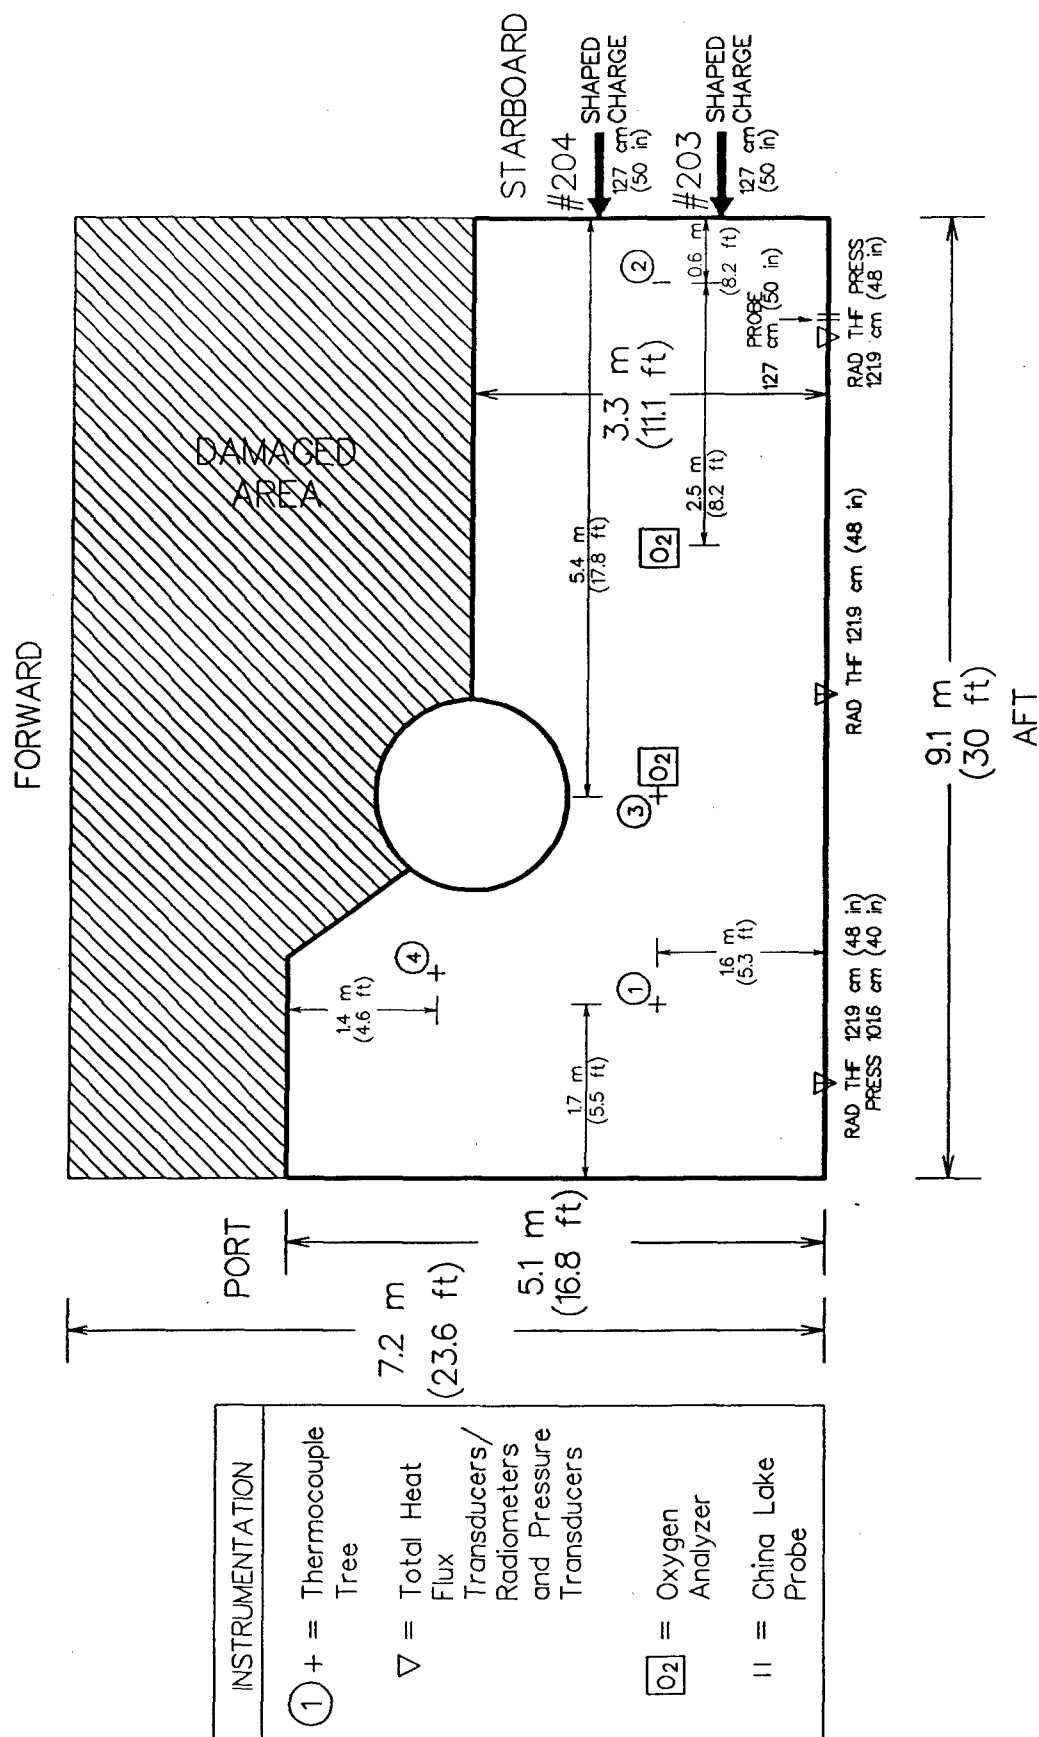
Fig. 6 - Instrumentation layout

heat flux, oxygen concentrations, and compartment blast pressures. The instrumentation scheme is shown in Fig.6. Due to safety requirements, the data acquisition systems were activated remotely from a control room located on the hanger deck well aft of the test compartment. A further description of the instrumentation is as follows.

Four Type "K" thermocouple trees (arrays) were placed in the test compartment. Three trees were positioned equidistant from port to starboard along the centerline of the compartment. The fourth tree was positioned in a void forward in the compartment. These trees consisted of three thermocouples, each spaced 0.6 m (2 ft) apart at heights of 0.6, 1.2, and 1.8 m (2, 4, and 6 ft) above the deck. The thermocouples were glass braided, 36 gauge wires having a response time/time constant of approximately 0.15 seconds.

Three Medtherm Schmidt-Boelter fast response (0.05 s response time) total heat flux transducers (Model 64-10F-205B) were mounted in the fire compartment. These transducers were installed at charge level, i.e., 1.25 m (50 in.) above the deck, on the aft bulkhead equidistant from port to starboard. From these measurements, the likelihood and time to ignition of various combustibles can be estimated.

Three Medtherm Schmidt-Boelter fast response (0.05 s response time) radiometers (Model 64-10F-205B, 1SW-1C-150) were also installed along side of the total heat flux transducers. These instruments measure the radiant exposures in the fire compartment. The

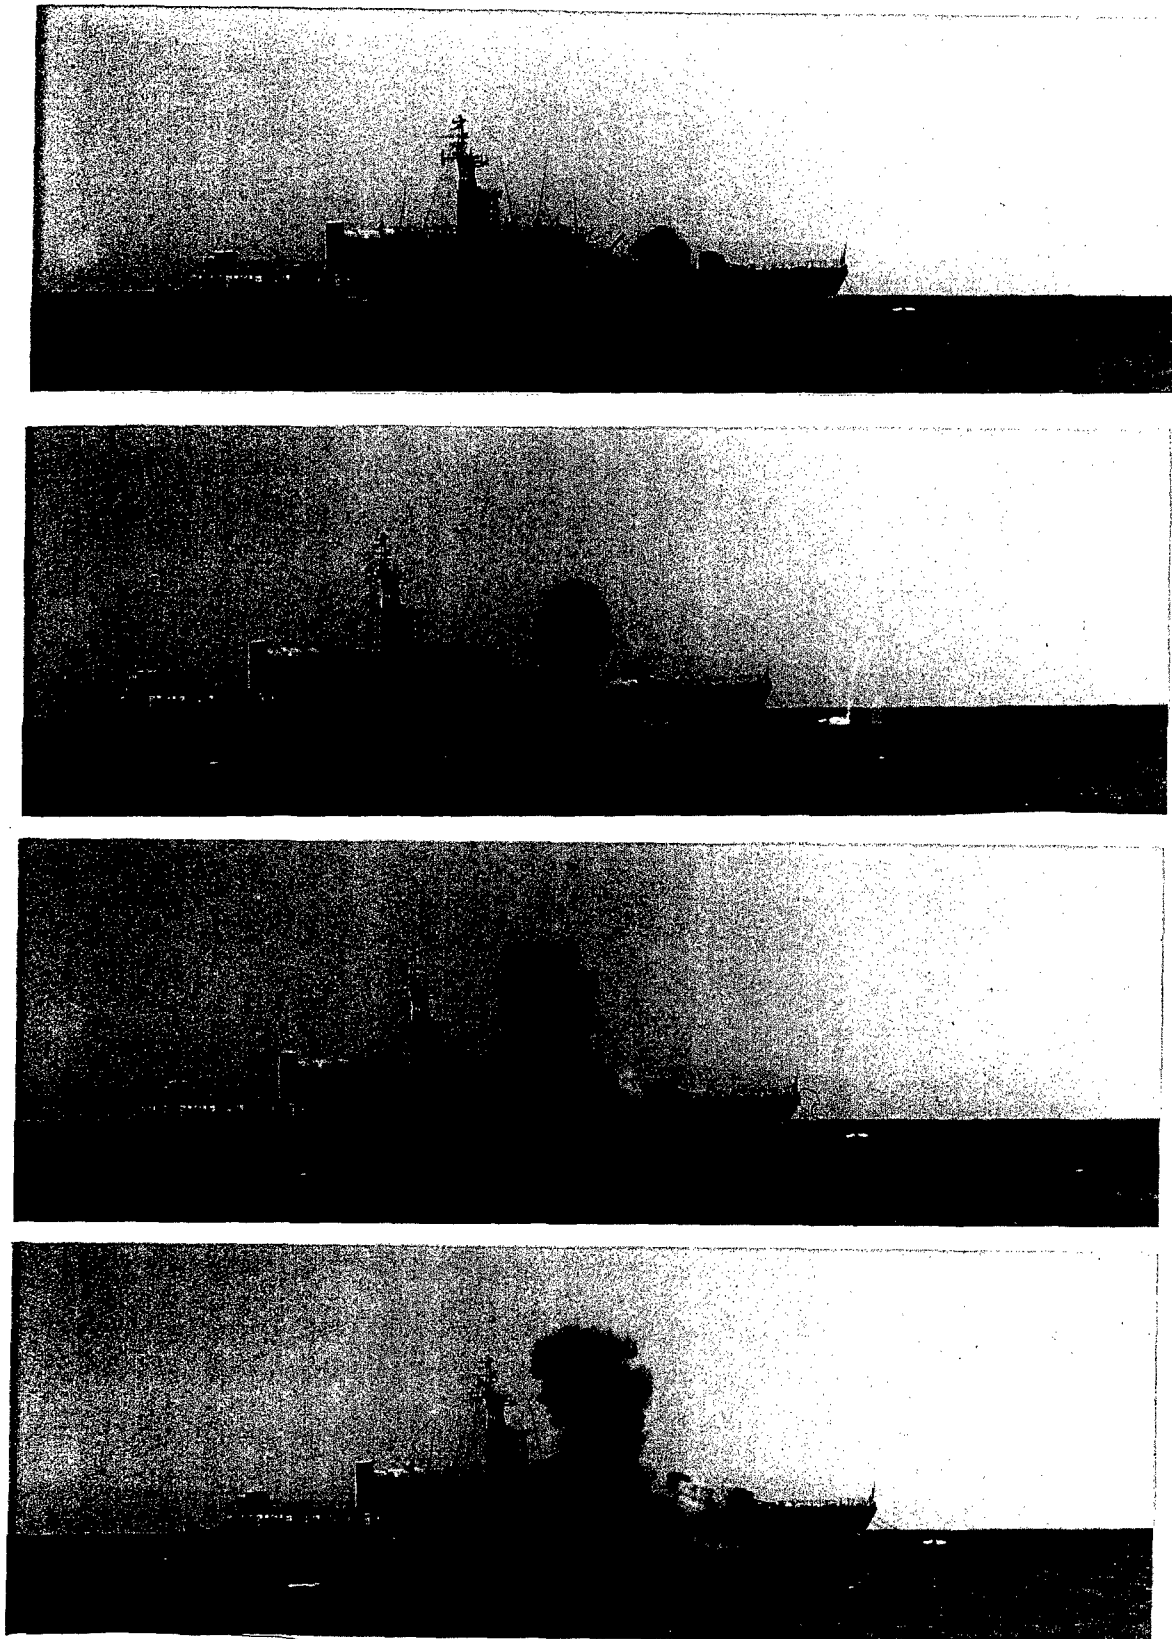
Fig. 7 - Martest 203 blast sequence

A series of photographs capturing the blast sequence for Test 1 is shown in Figure 7. The charge did not pass directly through the ship as anticipated. Instead the shaped charge entered the ship through the 1.25 cm (0.5 in.) thick hull on the starboard side and continued across the ship striking the aft bulkhead approximately three-quarters of the way across the compartment as shown in Fig. 8. The warhead cut an almost perfect circular opening through the starboard hull as shown in Fig. 9a. The blast fragment pattern was approximately 1.0 m (~ 3 ft) in diameter and consisted of holes and deep pits on the aft bulkhead as shown in Fig. 9b. Other than the area in the blast pattern and the hole through the hull, the compartment was relatively unaffected by the blast.

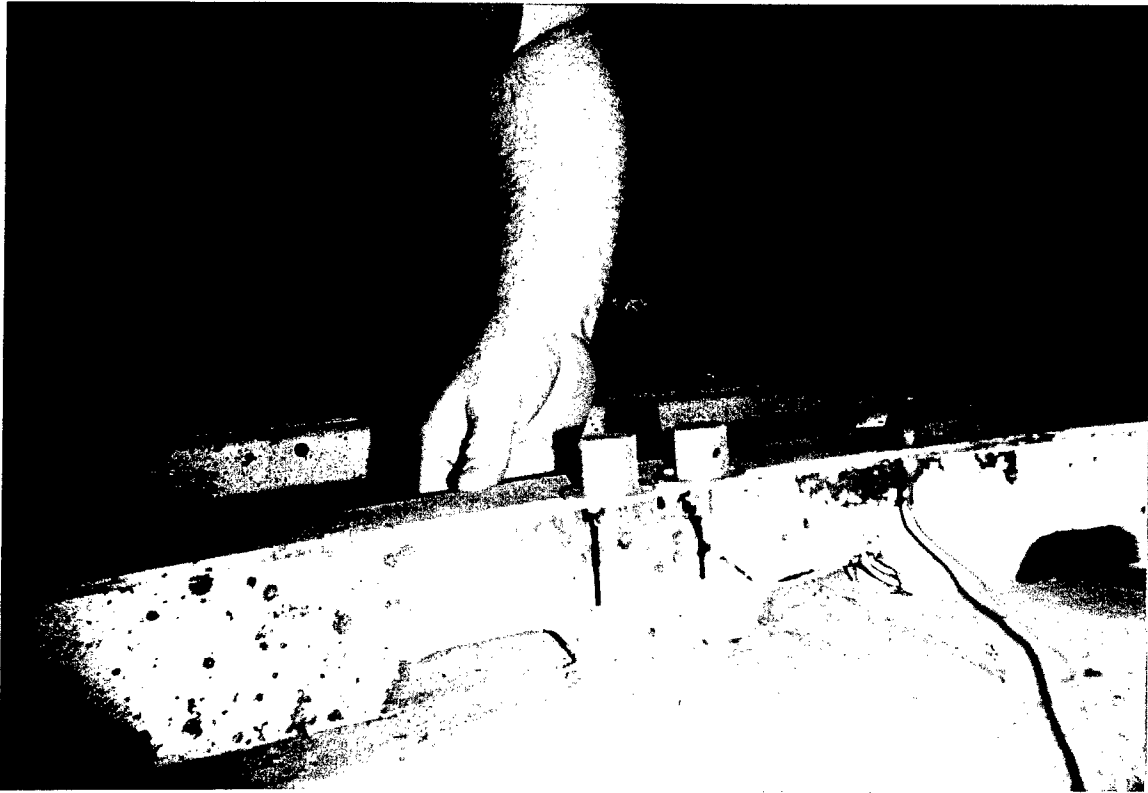
Fig. 9a - Martest 203 blast

Fig. 9b - Martest 203 fragment illustrations

Although the ignition indicators did not ignite, another possible source of ignition could have been hot fragments resulting from the SCJ. If hot fragments had landed on a Class A material, this too could have caused ignition. However, in this case, the hot fragments did not land on the ignition indicators, but rather impacted the bulkhead on the port side of the compartment.

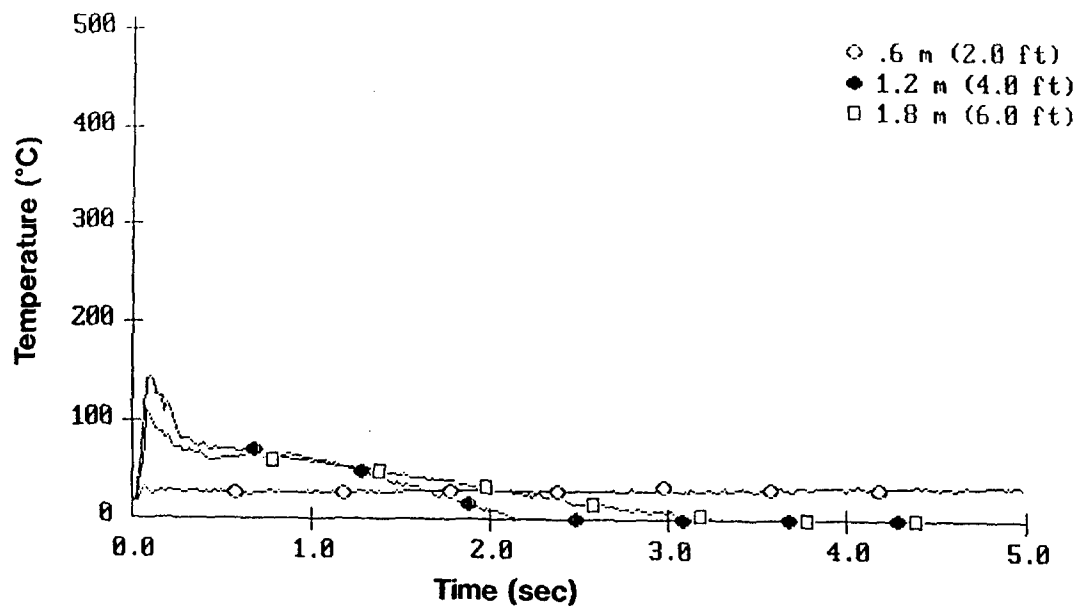
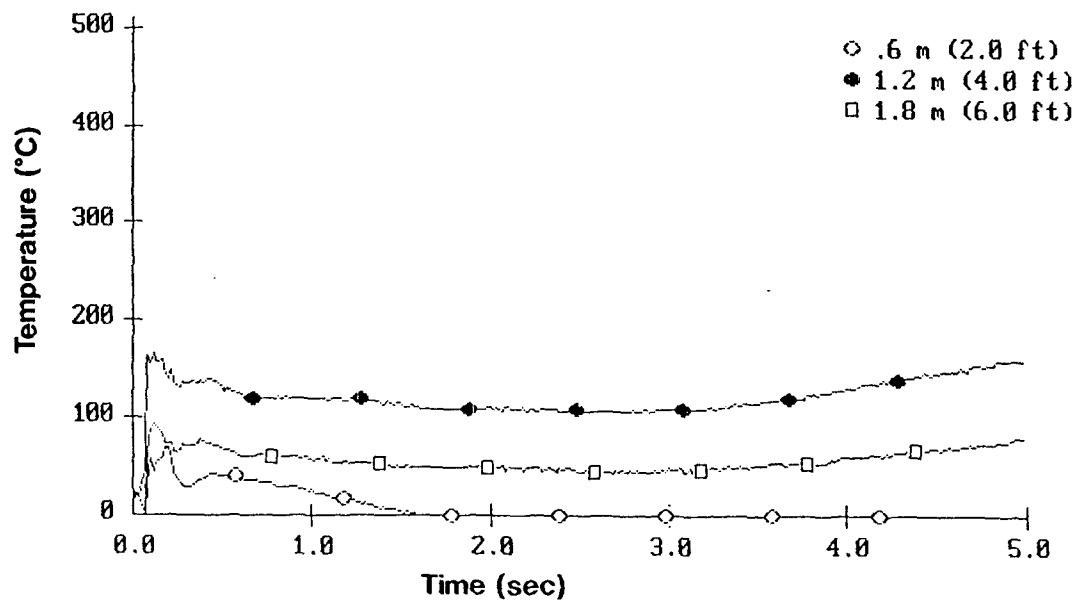
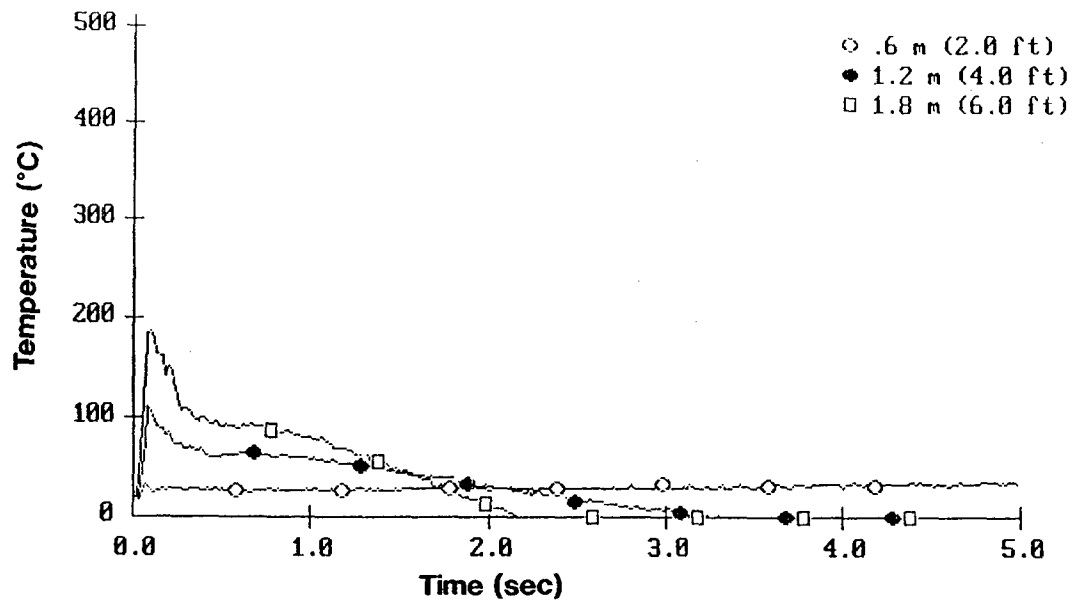
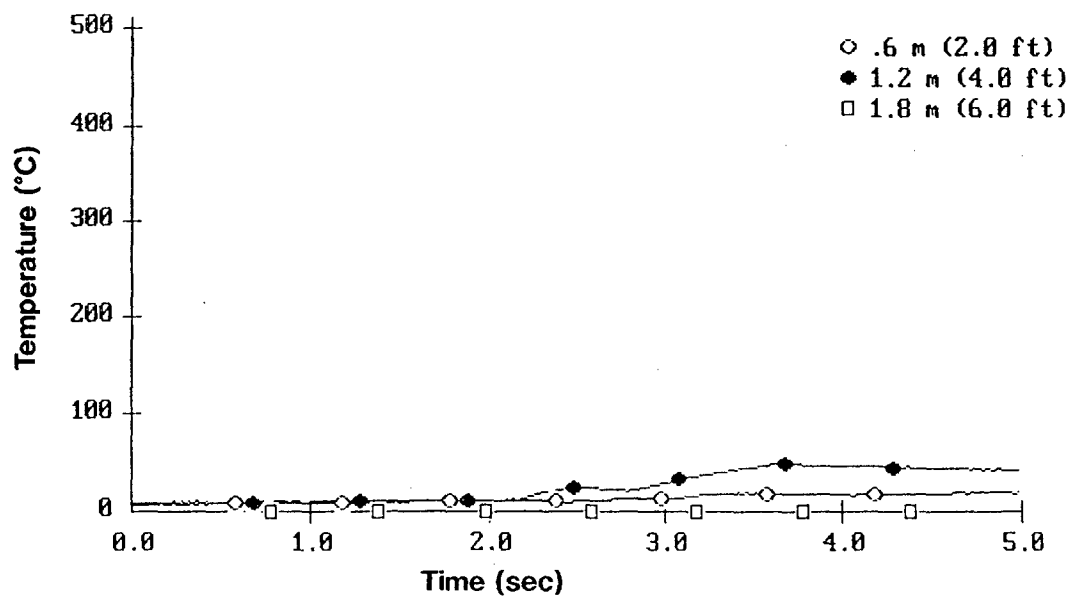
The thermal insult to the compartment resulting from the shaped charge jet was of low intensity and extremely short duration. The temperatures measured along the line of the shot (Figs. 10a - 10d) were found to increase rapidly, reaching a peak value of up to 190°C, depending on the height, and then rapidly decay, i.e., within two seconds the temperatures were back to baseline, i.e., 30°C. The center thermocouple tree (tree #3 - Figure 10b) was hit with blast fragments during this test resulting in a longer period of time for the thermocouples to return to ambient temperatures. The highest temperature recorded on each tree was measured at the approximate height of the shot (1.2 m (4 ft)). The overall thermal pulse was found to be higher on the port side of the ship than on the starboard side (where the jet originated). This may be attributed to two factors: (1) the convective heat transfer may have been greater on the port side due to the spreading of the blast pattern with increased distance from the charge; and (2) when the fragments (molten metal) struck the port bulkhead, small amounts of materials (paint, etc.) may have briefly ignited. On the other hand, the temperature rise in the area remote from the blast (Tree 4) was negligible.

Fig. 10a - Fire compartment temperatures (starboard tree #2) Test #1

Fig. 10b - Fire compartment temperatures (center tree #3) Test #1

Fig. 10c - Fire compartment temperatures (port tree #1) Test #1

Fig. 10d - Fire compartment temperatures (forward tree #4) Test #1

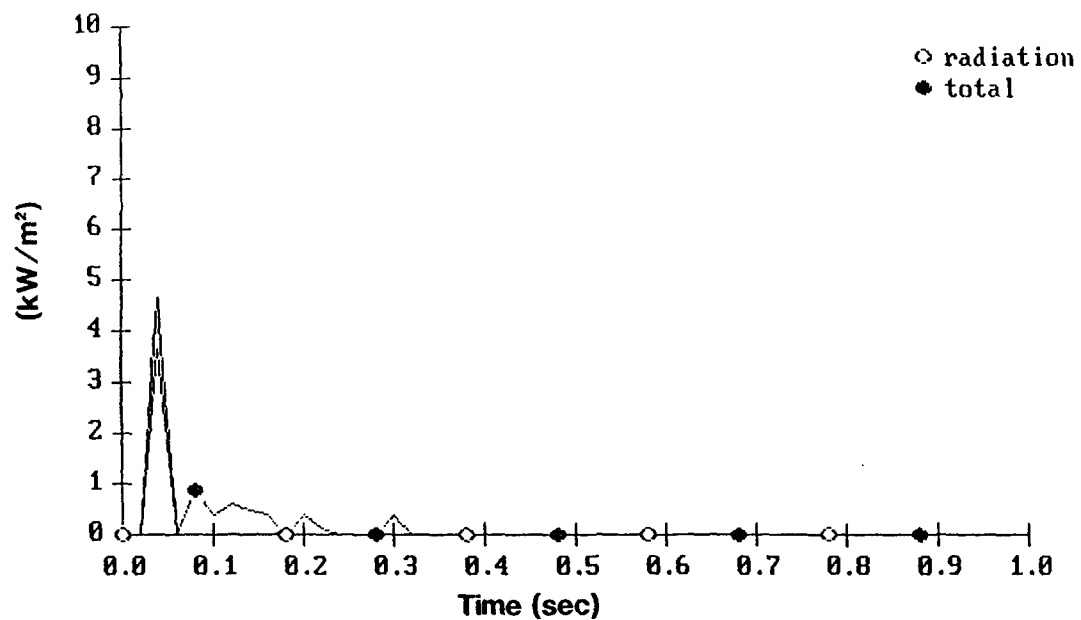
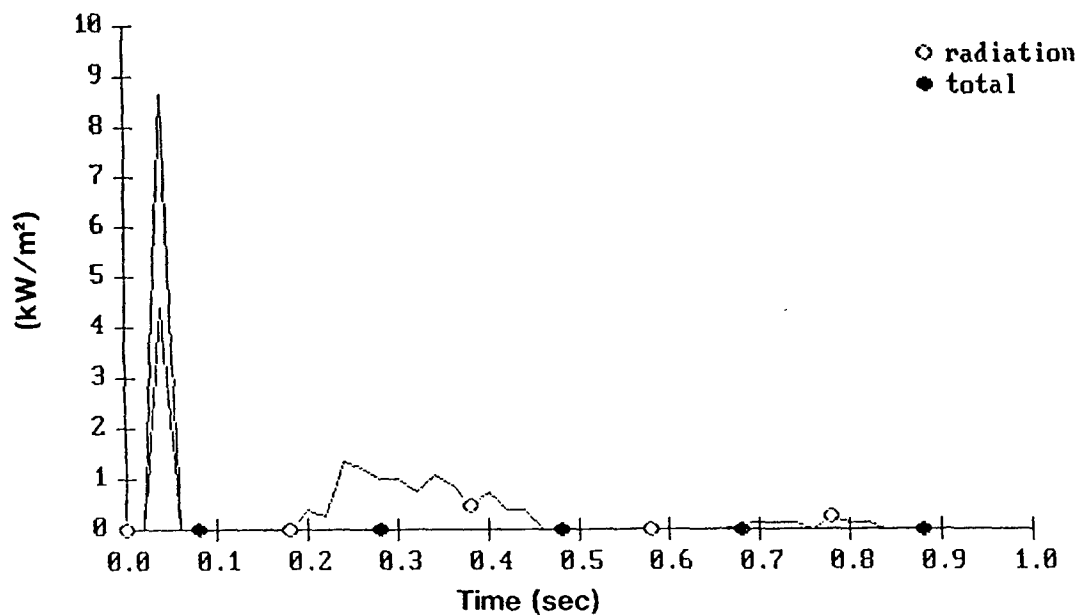
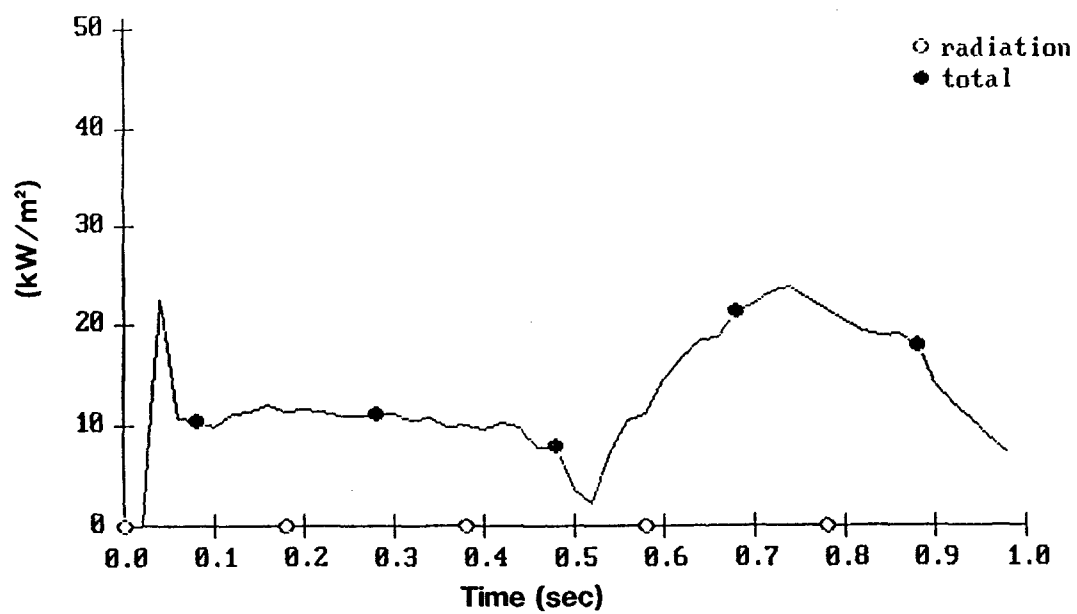
The radiant and total heat flux measurements also followed the same trend with the fluxes increasing with increased distance from the blast (Figs. 11a-c). The peak values were reached in less than 50 ms. In this case, this higher exposure on the port side may not only be attributable to the spreading of the pattern or localized ignition but may also be a function of the distance between the radiometers and the plasma jet. The jet struck the aft bulkhead near the port side of

Fig. 11a - Fire compartment exposures (starboard) Test #1

Fig. 11b - Fire compartment exposures (center) Test #1

Fig. 11c - Fire compartment exposures (port) Test #1

the ship shortening the distance between the jet and the radiometers at this location. The maximum total heat flux was recorded as 22.5 kW/m² (2.0 Btu/ft² sec). The maximum radiant flux was measured as 4.5 kW/m² (0.4 Btu/ft² sec). For comparison, it was shown in separate test that a total exposure on the order of 150 kW/m² sec is required to ignite paper [7]. When considering the thermal/radiant exposure produced by the charge only lasts 0.1 seconds, a heat flux of 1500 kW/m² would be required to cause ignition, far in excess of the peak value of 22.5 kW/m² recorded in this run.

The radiant and total heat flux measurements were also dramatically higher for the second test (compare Figs. 11a-c and 19a-c). The maximum exposures were measured on the starboard side of the ship with both the radiation and total heat flux levels reaching values over 60 kW/m^2 (Fig. 19a). This increase was well over an order of magnitude greater than those measured during the first test. The exposures in the center of the compartment were also observed to increase a factor or two from the first test (averaged from 6.5 kW/m^2 to 12.5 kW/m^2) (see Fig. 19b). Although the heat fluxes recorded in Martest 204 were higher than in Martest 203 and of longer

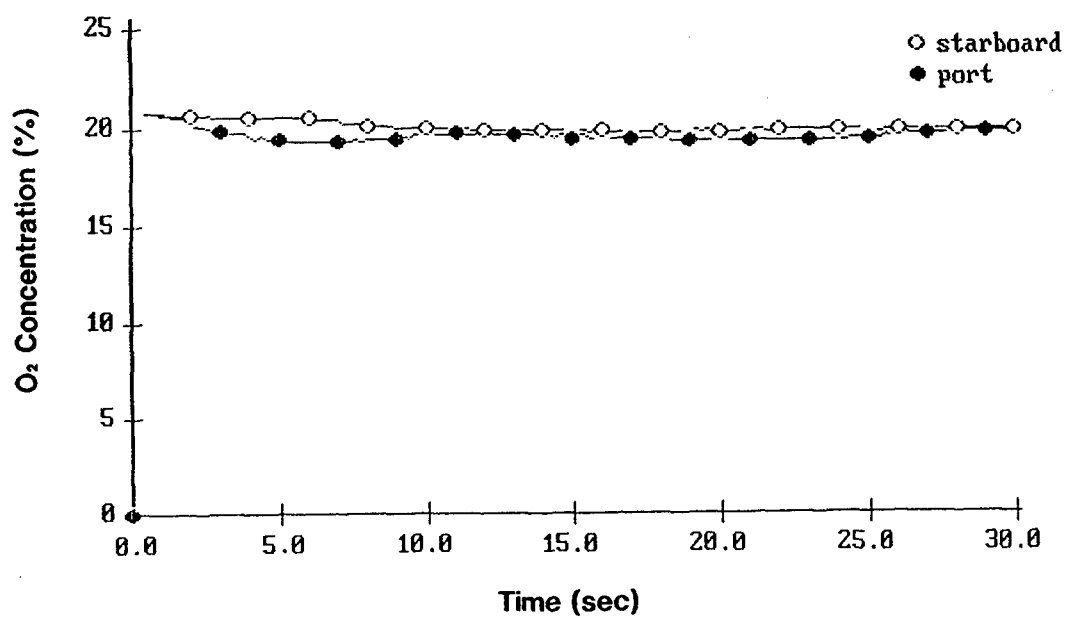
Fig. 12 - Fire compartment oxygen concentrations Test #1

The oxygen concentrations during this test (Fig. 12) remained fairly constant at about 20 percent although there was a slight momentary drop to 19 percent on the port side, suggesting some minor burning in this area. At any rate, the oxygen concentration in the compartment was high enough throughout the test to support combustion if any Class A material had been ignited.

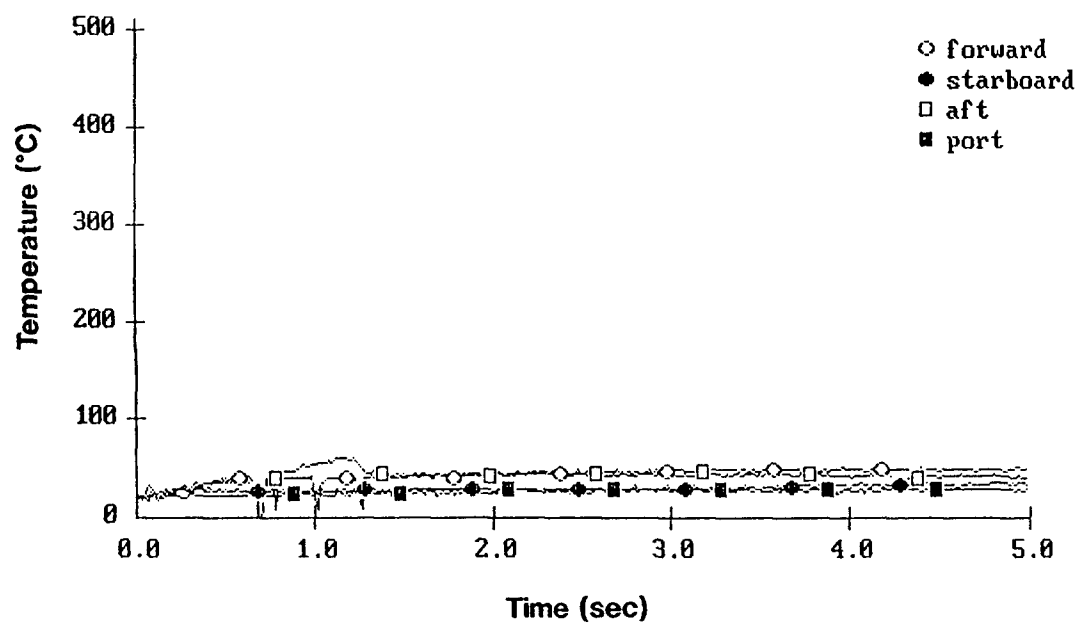
Fig. 13 - Ignition indicator temperatures (all) Test #1

The low intensity short duration thermal pulse had no effect on the four ignition indicators as shown in Fig. 13. The thermocouples positioned in/above the materials recorded temperature increases of less than 30°C. For comparison, the accepted spontaneous ignition surface temperature of Class A materials is 400-500°C [4], almost three times that recorded anywhere in the compartment.

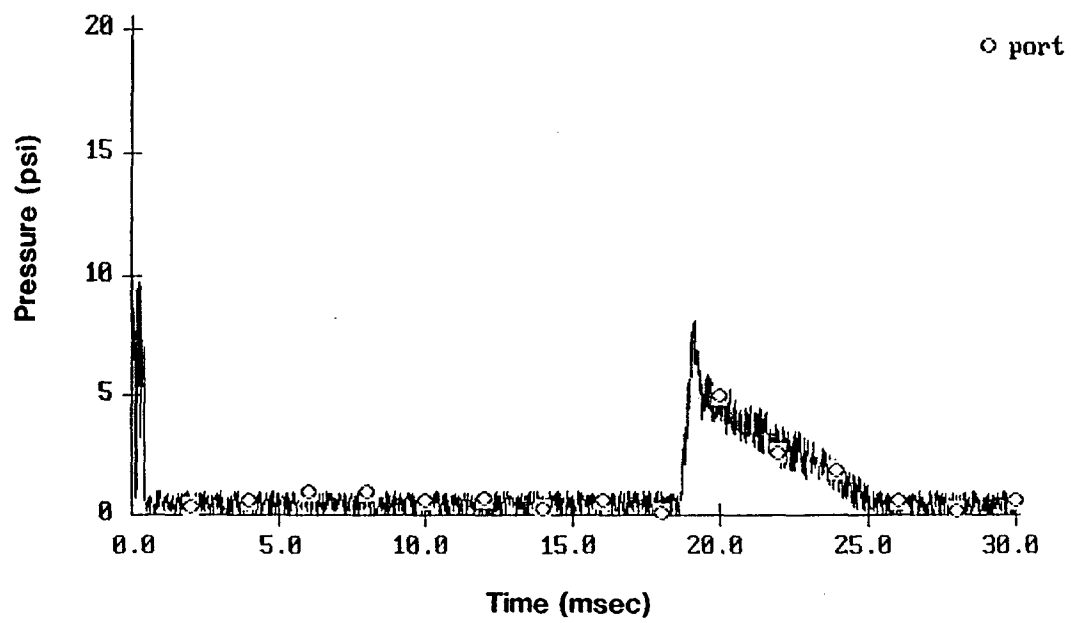
Fig. 14 - Fire compartment pressures in Martest 203

Although two pressure transducers were also installed for this test, the transducer on the starboard side of the ship was damaged by the blast, and hence, no readings were obtained at this point. However, the port pressure transducer worked properly and recorded a peak pressure of 51.7 kPa (7.5 psi) 19 ms after the blast (Fig. 14). The duration of the pressure wave was measured to be 5 milliseconds (ms). This relatively high pressure, but short duration pulse

inflicted no visible damage on the compartment. (The initial pressure spike at < 1.0 ms was attributed to the detonation of the warhead.)

The combustion of the liquid fuel had very little effect on the shape of the pressure curve. A comparison of the pressure readings for Martests 203 and 204 (Figs. 14 and 22) shows that the peak pressures were approximately the same in both tests (8 psi in Martest 203 and 7 psi in Martest 204), but the pressure was drawn out for an additional 5 ms in Martest 204. The shape of the pressure pulse indicates an initial spike in pressure due to the hull penetration and then a sustained pressure as the fuel/air cloud ignited. The only explanation for the similarity in magnitude between the two tests was the presence of the opening produced during the first test which may have served to vent a portion of the pressure pulse in the second test.

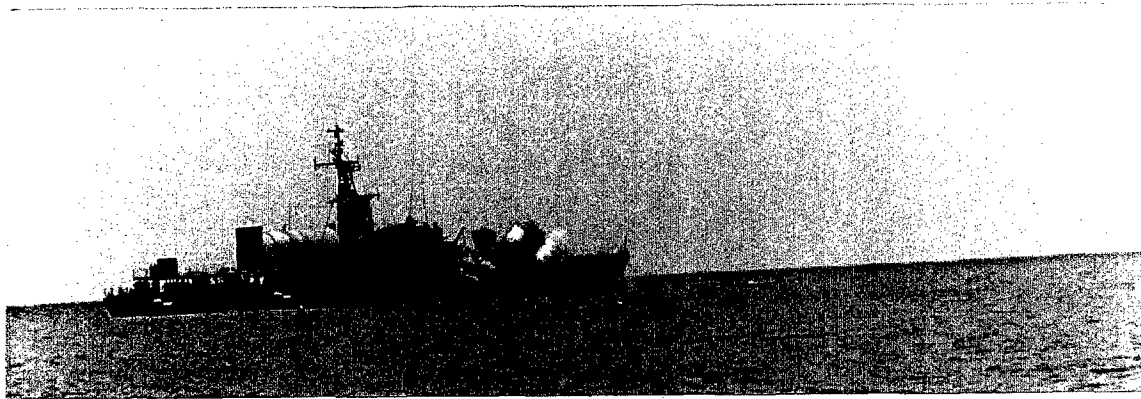
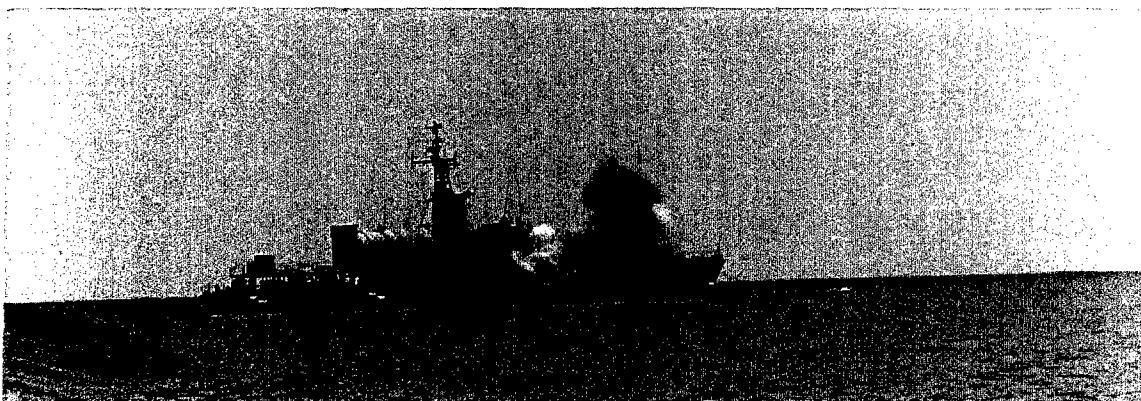
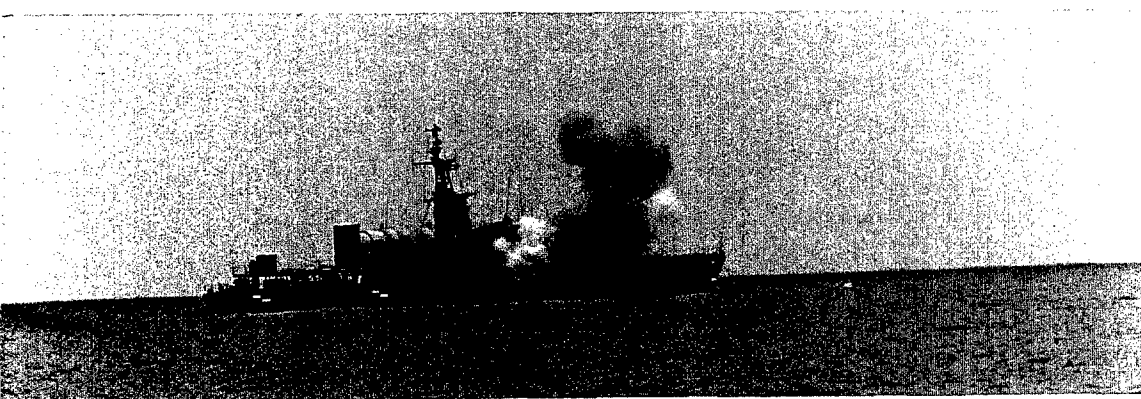
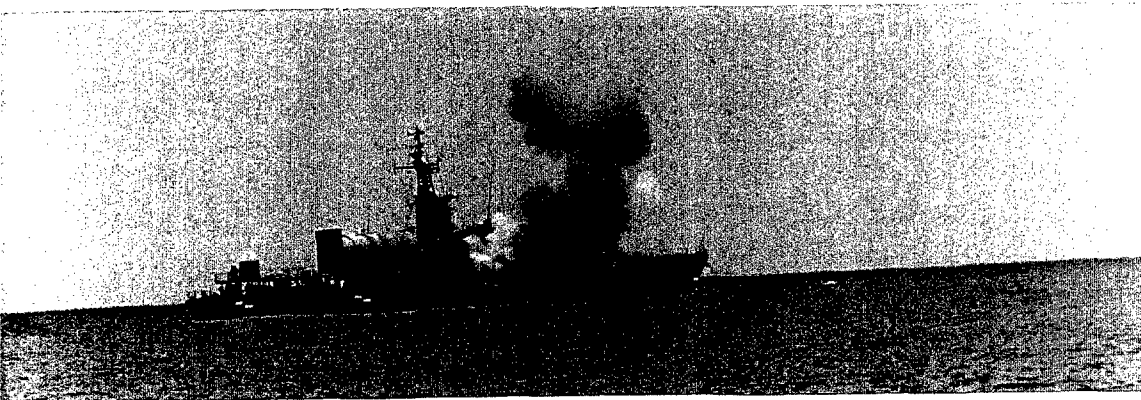
Fig. 15 - Martest 204 blast sequence

A series of photographs capturing the blast sequence in Martest 204 is shown in Fig. 15. The jet did not cut cleanly through the hull as in Martest 203, but rather left two semicircular openings which served to deflect the jet towards the overhead and towards the deck (Fig. 16a). The same types of openings (Figs. 17a and 17b) were observed in the China Lake tests [2], namely a clean hole when no fuel tank was used (Fig. 17a) and a partially cut hole when the fuel tank was placed in front of the SSCJ warhead. In Martest 204, it appeared that the majority of the diesel fuel carried by the blast was entrained through the upper opening, producing an inefficient fuel/air explosion at this location. This is evident by the residue/char pattern observed on the overhead at this location (Fig. 16a). A portion of the jet did, however, pass through the entire ship exiting the port bulkhead. The presence of the fuel tank significantly altered the conditions in the compartment.

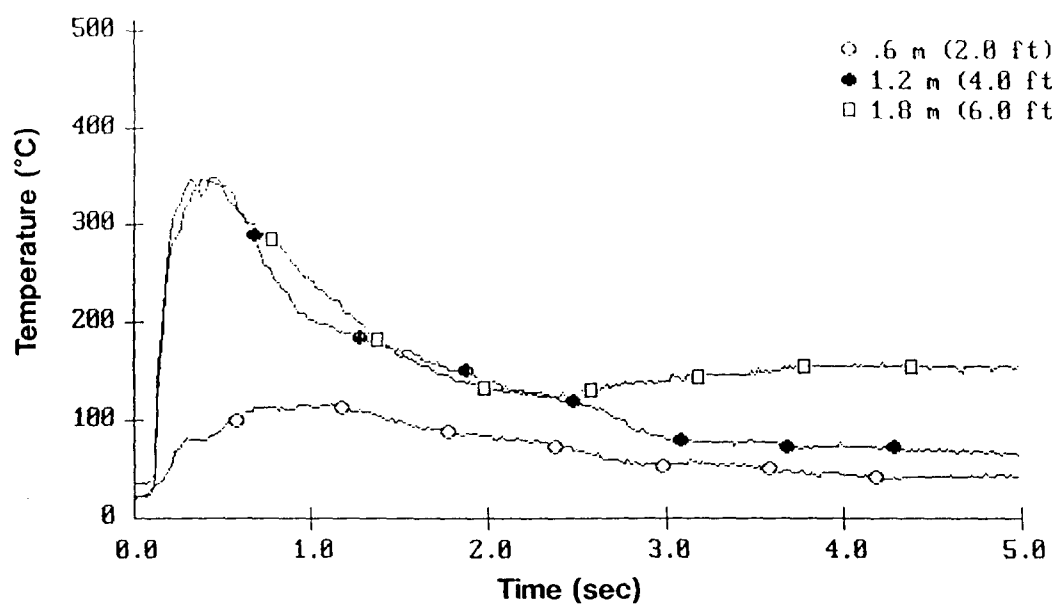
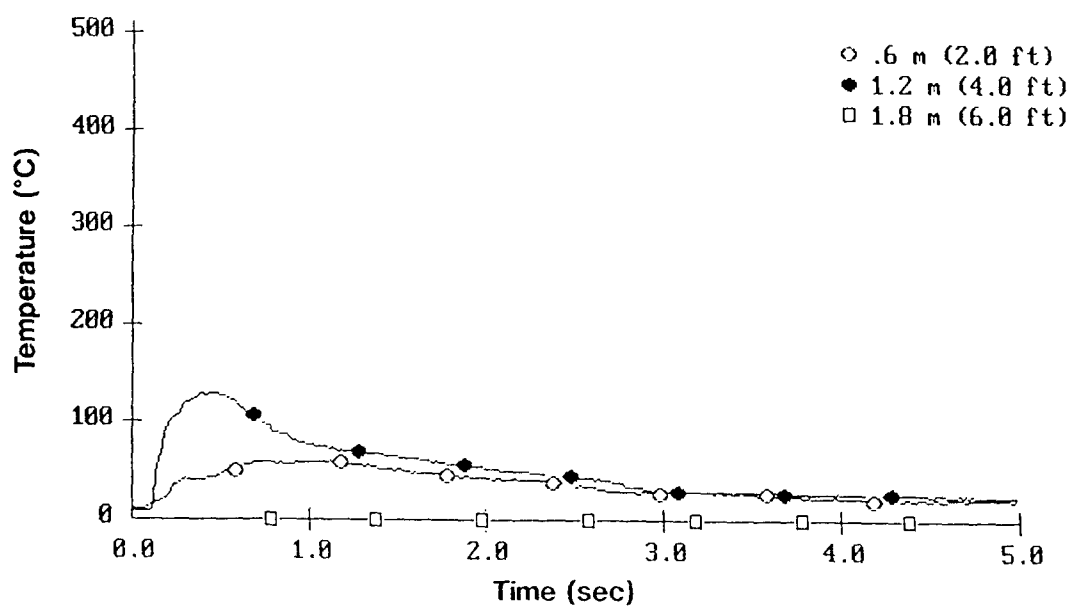
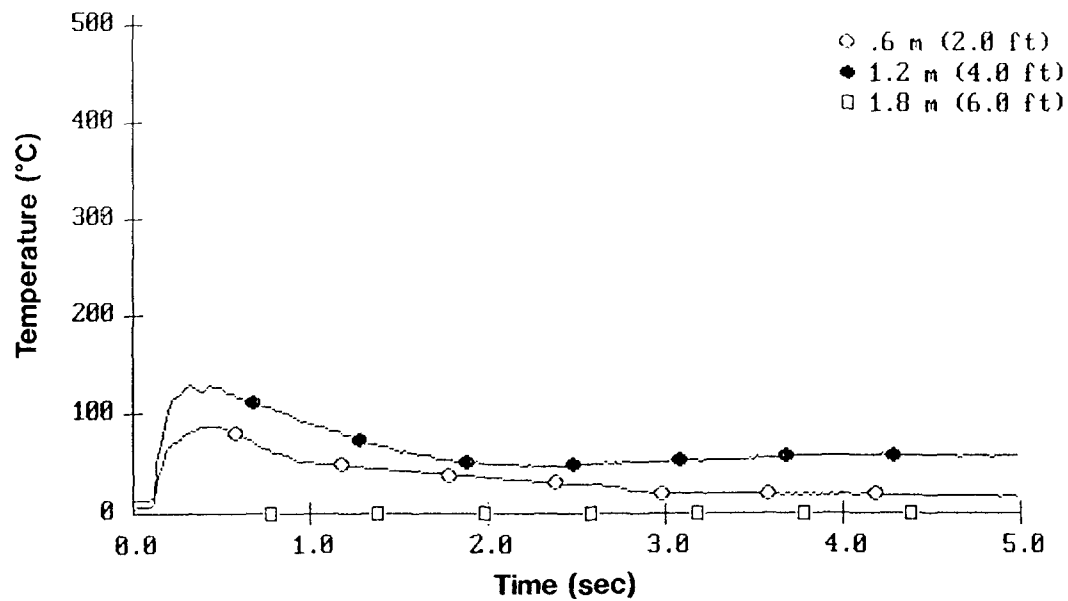
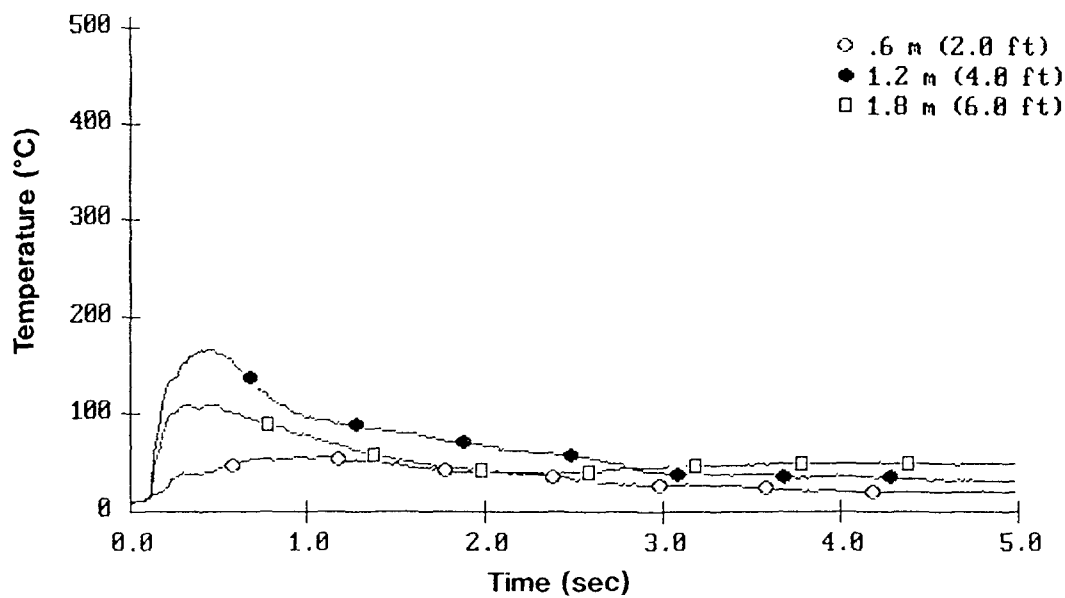
The temperature profiles obtained for the second test (Martest 204) are shown in Fig. 18a-d. The most severe thermal conditions occurred on the starboard side of the ship rather than on the port as in the previous test (compare Figs. 18a and 10a). This was attributed to the inefficient fuel/air explosion. The temperatures measured during this test reached 350°C on the starboard side decreasing across the compartment to 125°C on the port side. The duration of the pulse was also lengthened from less than a half-second to over a second by the combustion of the fuel as shown in Fig. 18a-d.

Fig. 18a - Fire compartment temperatures (starboard tree #2) Test #2

Fig. 18b - Fire compartment temperatures (center tree #3) Test #2

Fig. 18c - Fire compartment temperatures (port tree #1) Test #2

Fig. 18d - Fire compartment temperatures (forward tree #4) Test #2
